Final Report No. 2050

concerning the accident

involving the EXPRESS 2000 ER aircraft, registration HB-YMN

on 23 July 2007

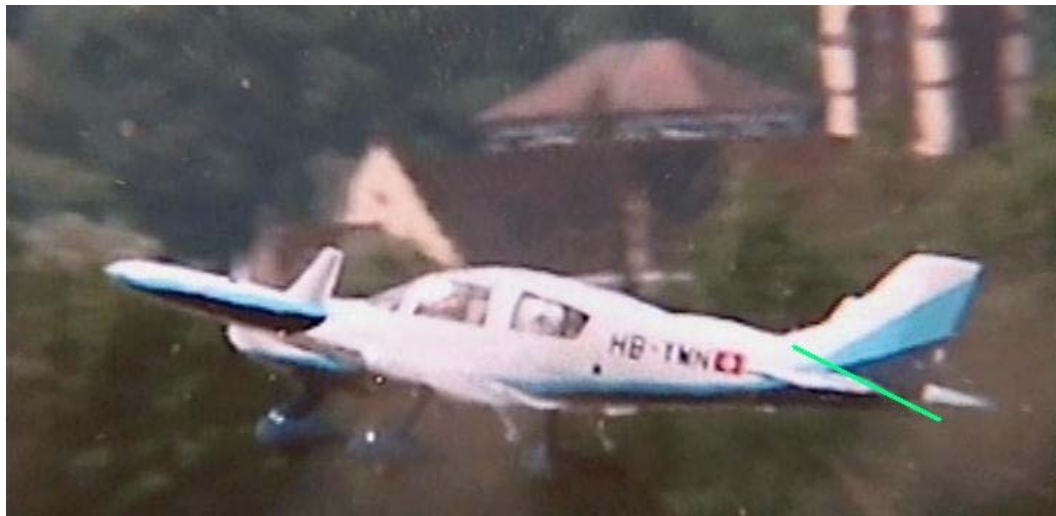
The aircraft did not lift off until the area of the intersection of the two runway systems, i.e. after a 3400 m take-off roll. It was at a high angle of attack and was unstable around the longitudinal axis. At this time the elevator was deflected downwards.

Fig. 2: Aircraft shortly after take-off with elevator deflected down (freeze out of video)

The visibly unstable progress of the flight after the extraordinarily long take-off roll indicates that the aircraft's speed was too low.

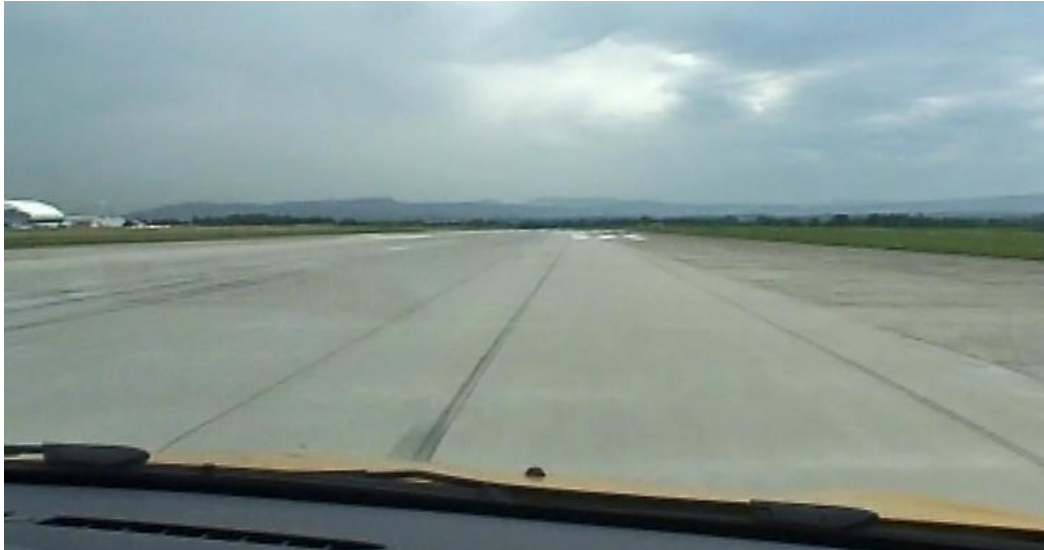
During a runway inspection after the accident, two continuous black rubber abrasion marks were found in a zone of approximately 800 m from the runway 16 threshold up to the intersection with runway 26; these were caused by the two main wheels of aircraft HB-YMN.

Fig. 4: Tyre marks on the runway

The observed generation of smoke from both wheel fairings, the documented rubber abrasion marks approximately 2.6 km long on the runway, the wear of the bearing surface of the tyre which was found after the accident, and the progress of acceleration, support this hypothesis.

- After the accident, black marks from abraded rubber, approximately 2.6 km in length, were found on runway 16; these originated from the two tyres of the main landing gear.

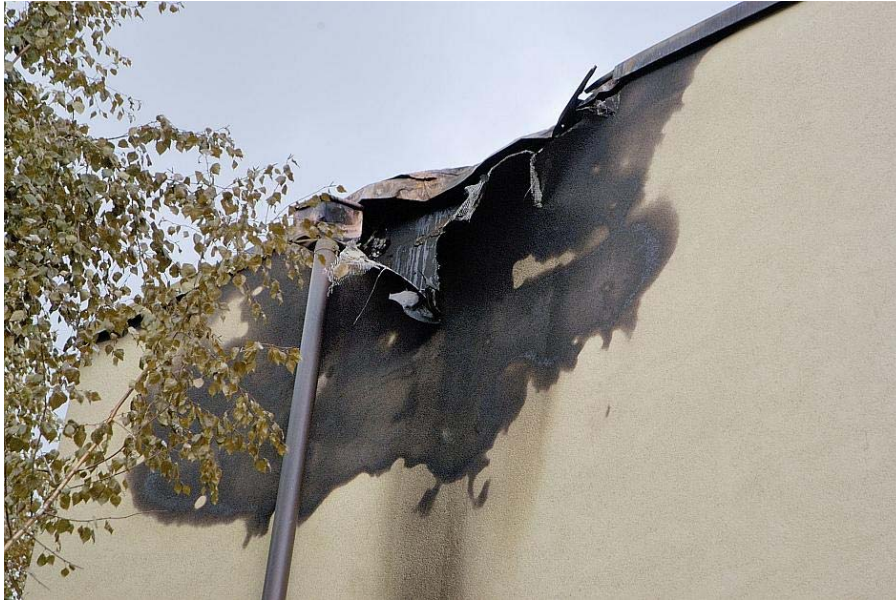
On initial impact the wingtip tanks were torn off and the aircraft penetrated the attic. Since the impact was not quite symmetrical, the aircraft turned to the right around its vertical axis.

Fig. 5: Point of impact on the north-west side of the building at Roggenburgstrasse 15

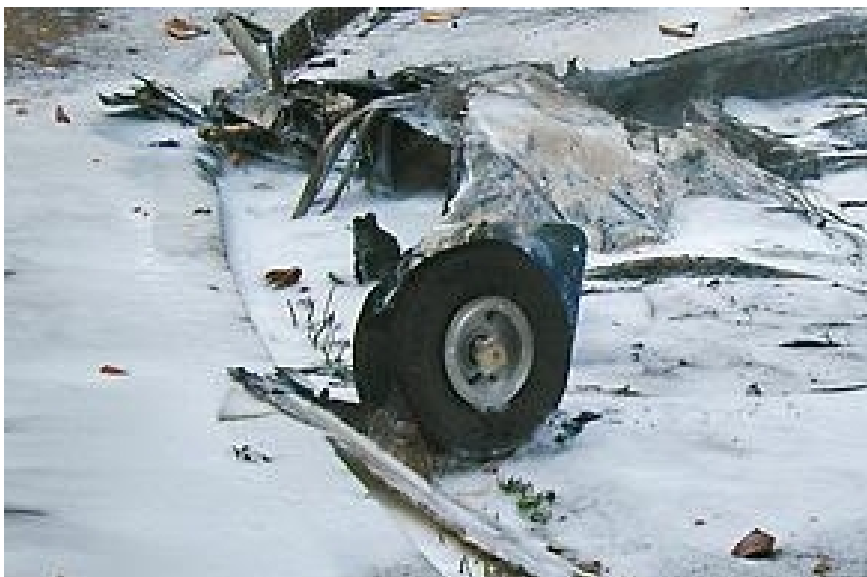
The left landing gear and the left wing were to a large extent destroyed by the fire. The right landing gear, apart from the missing wheel cowling, was largely preserved. The right tyre was scorched.

Fig. 6: Scorched tyre of the right wheel

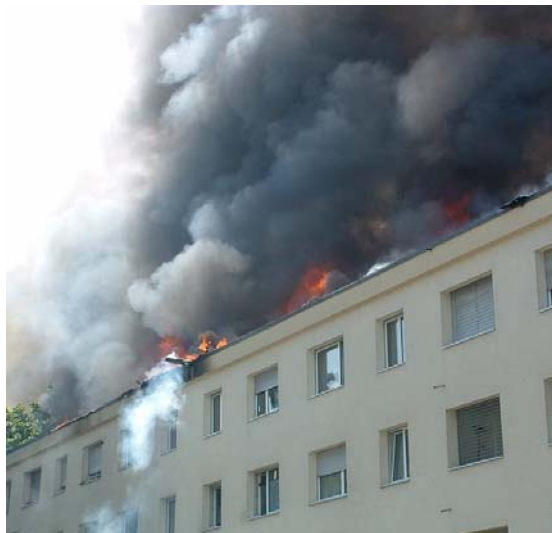
The attic of the properties at Roggenburgstrasse 9-15 was completely consumed by fire. Further damage was caused to the building by the fire-fighting and recovery work. The buildings were subsequently uninhabitable for a fairly long period.

Fig. 7: Attic of the property at Roggenburgstrasse 9 – 15 on fire

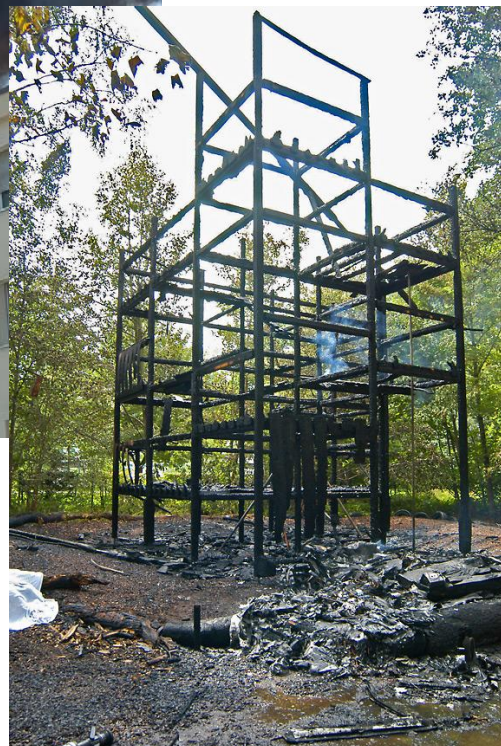
Parts of the aircraft and leaking fuel fell onto a children's playground area. Some of the equipment was destroyed by fire.

Fig. 8: Burnt-out climbing frame in the adjacent playground

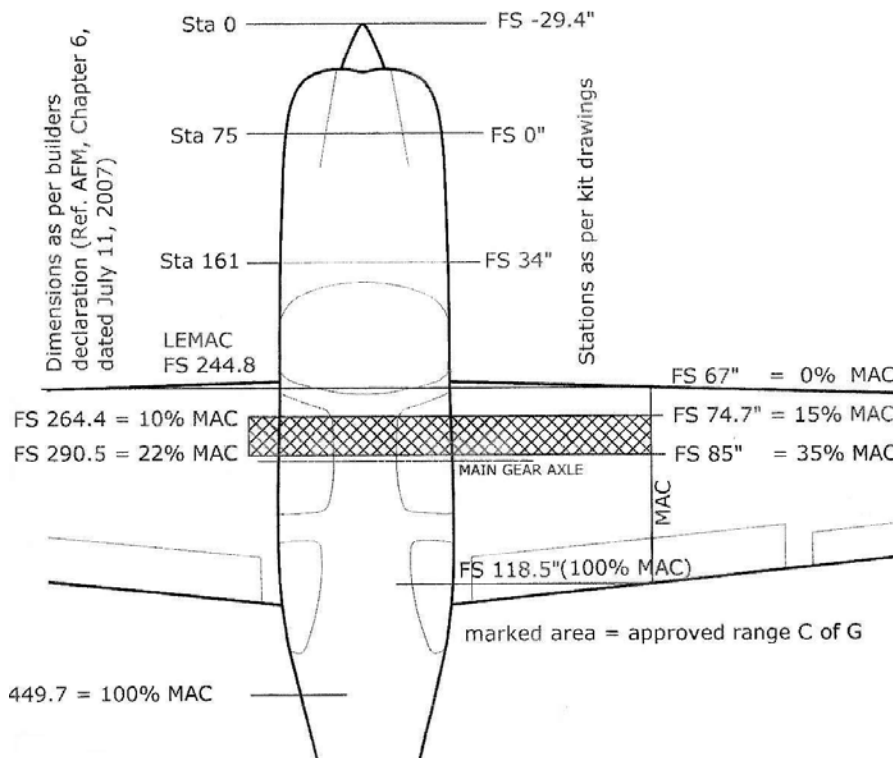
Using a spreadsheet software application, the builder had programmed a tool to calculate the mass and centre of gravity position of the aircraft. However, an incorrect wing chord value was used to convert the centre of gravity position to % MAC, resulting in 100% MAC located about 70 cm aft of the wing trailing edge.

Fig. 9: Comparison of Fuselage Station Data

Based on this erroneous data, the pilot calculated a centre of gravity location for the flight in overweight-condition of 22% MAC. His results expressed in % MAC were erroneous. His calculations in centimetres however were correct. According to his spreadsheet, he expected a take-off mass of 2431.7 kg.

As a result of the error in the conversion of the fuselage stations, the pilot's calculation resulted in a centre of gravity position of 22% MAC for the flight in overweight condition. This result gave him the false impression of a centre of gravity in the forward chord quarter. Correctly calculated, however, the centre of gravity would have been at 35% MAC, and with the actual load even at 35.8% MAC, i.e. in the second quarter of the chord.

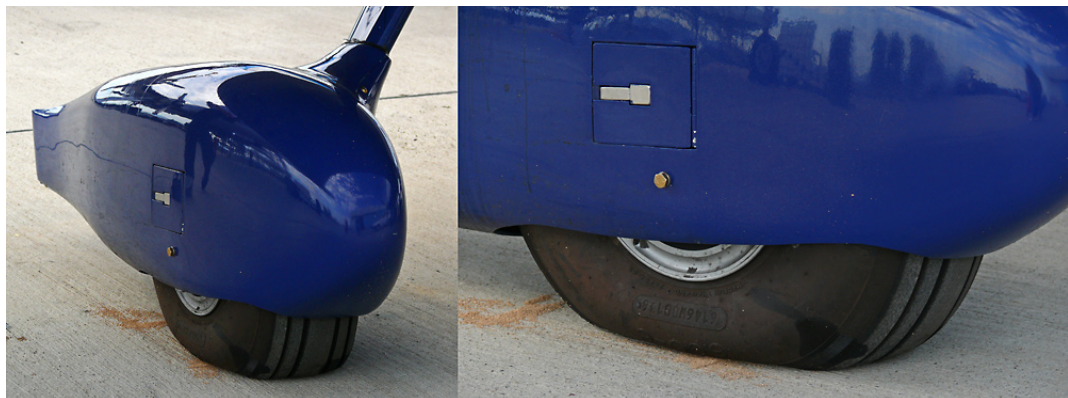
Fig. 11: Right wheel with tyre in mint condition

Major deflection due to heavy load

These pictures also show that at this time the tyre appeared as new and exhibited no apparent indications of wear.

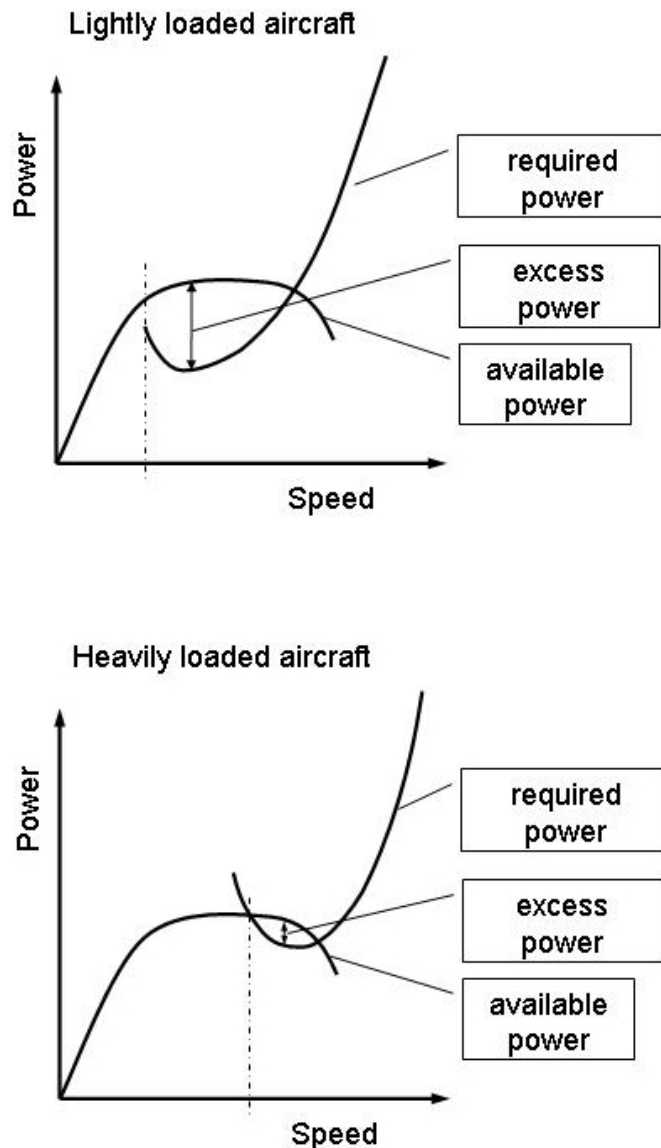
The fact that this condition did not change indicates that the aircraft, regarding excess power, was in an indifferent flight condition, i.e. drag and thrust were just balanced. Evidently sufficient excess power was not available. Therefore the pilot was not able to accelerate the aircraft to the range of excess power. As a result, it was not possible to climb and the continuation of the flight was not possible.

Fig. 13: Effect of take-off mass on excess power (qualitative depiction)
