Final Report No. 2050

concerning the accident

involving the EXPRESS 2000 ER aircraft, registration HB-YMN

on 23 July 2007

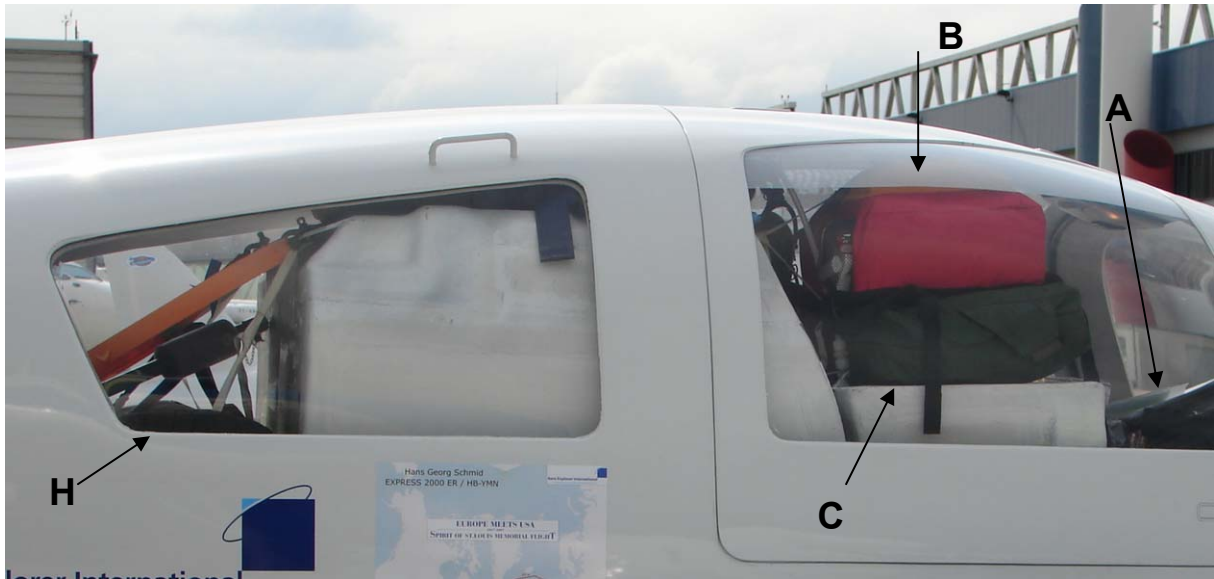
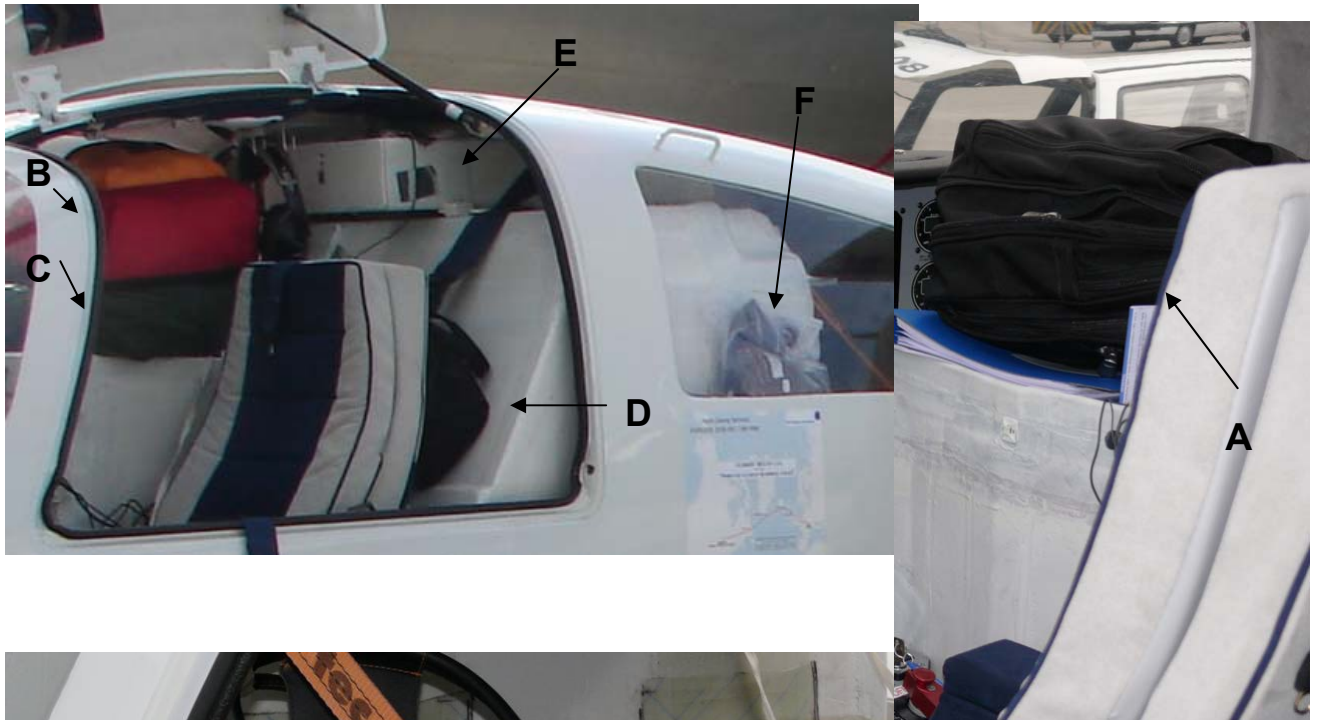
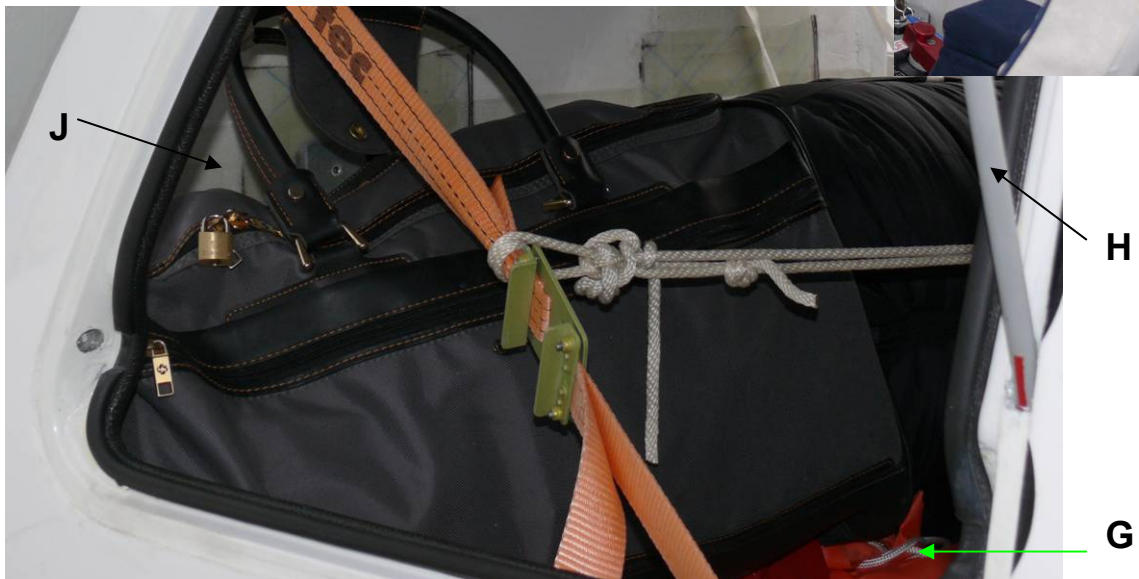
Note 3: Estimation based on photos taken before departure of the baggage below:

Black bag on FWD AUX tank	A
Red suitcase on FWD AUX tank	B
Olive pouch below red suitcase (with boat?)	C
Black pouch behind pilot	D
Container on top of AFT AUX tank, behind pilots head	E
Brown bag behind LH side window	F
Red bag in lower part of baggage compartment	G
Olive pouch in baggage compartment (like sleeping bag)	H
